APPENDIX B: Existing Conditions

Existing Conditions

B.1 Introduction

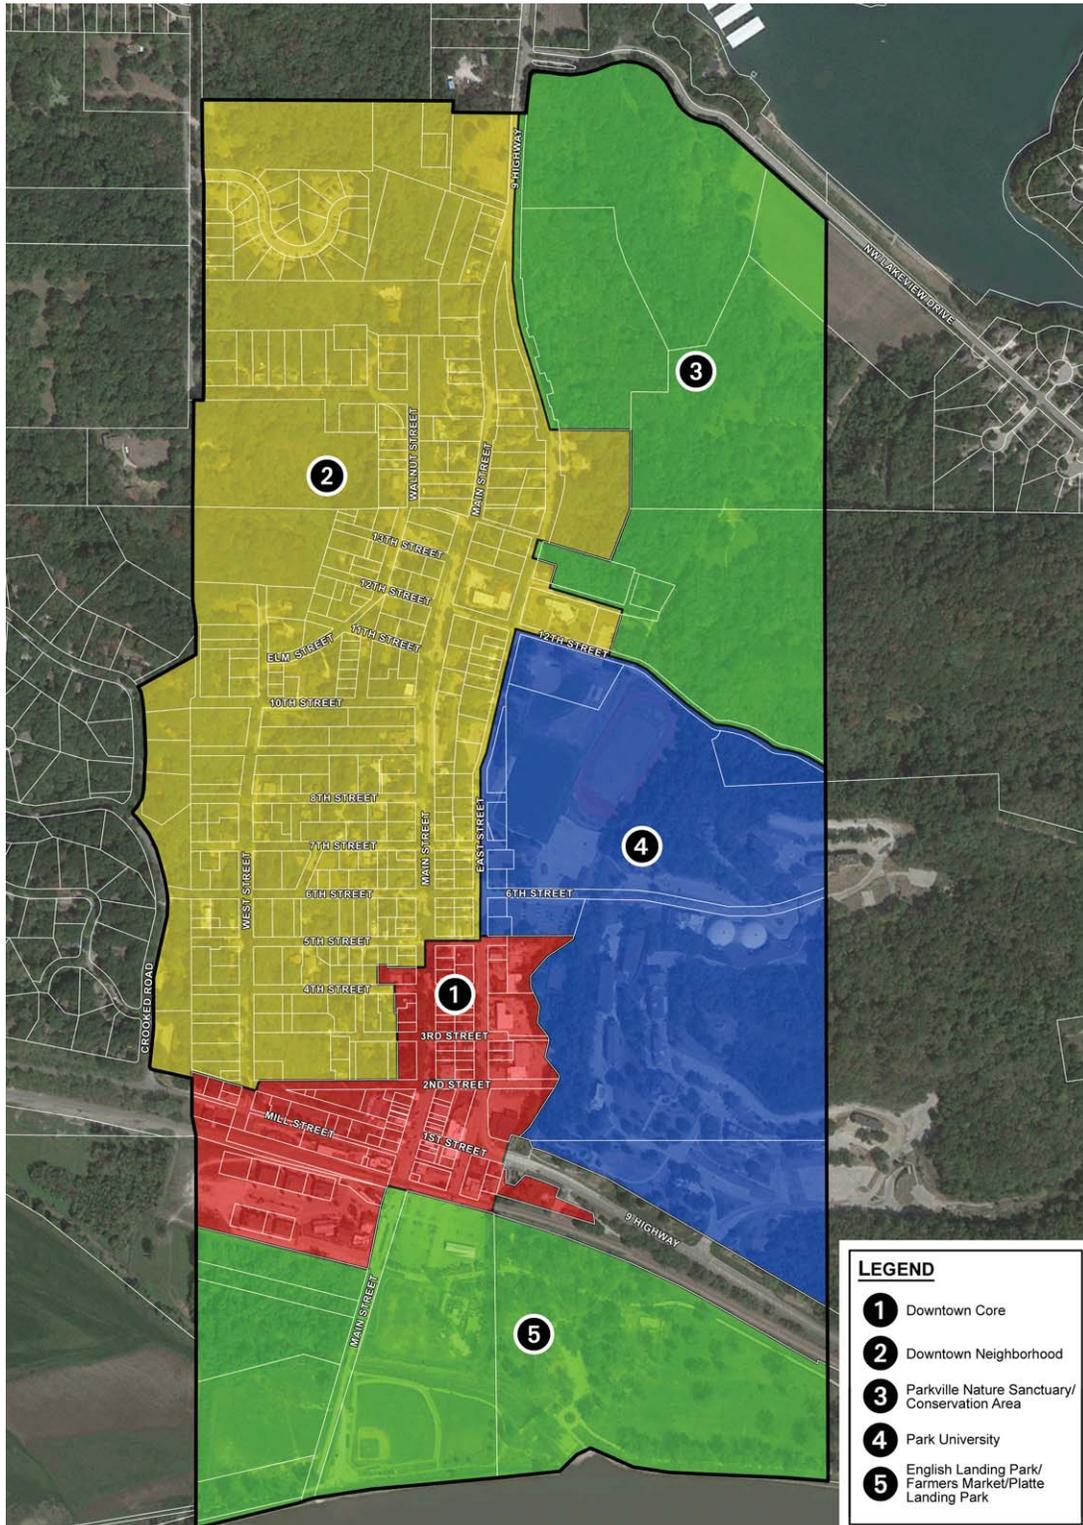
Fig. B.2 – Existing Land Use Diagram

Downtown has been divided into five (5) areas, as seen in Figure B.2. What follows is a description of the existing land uses within each area.

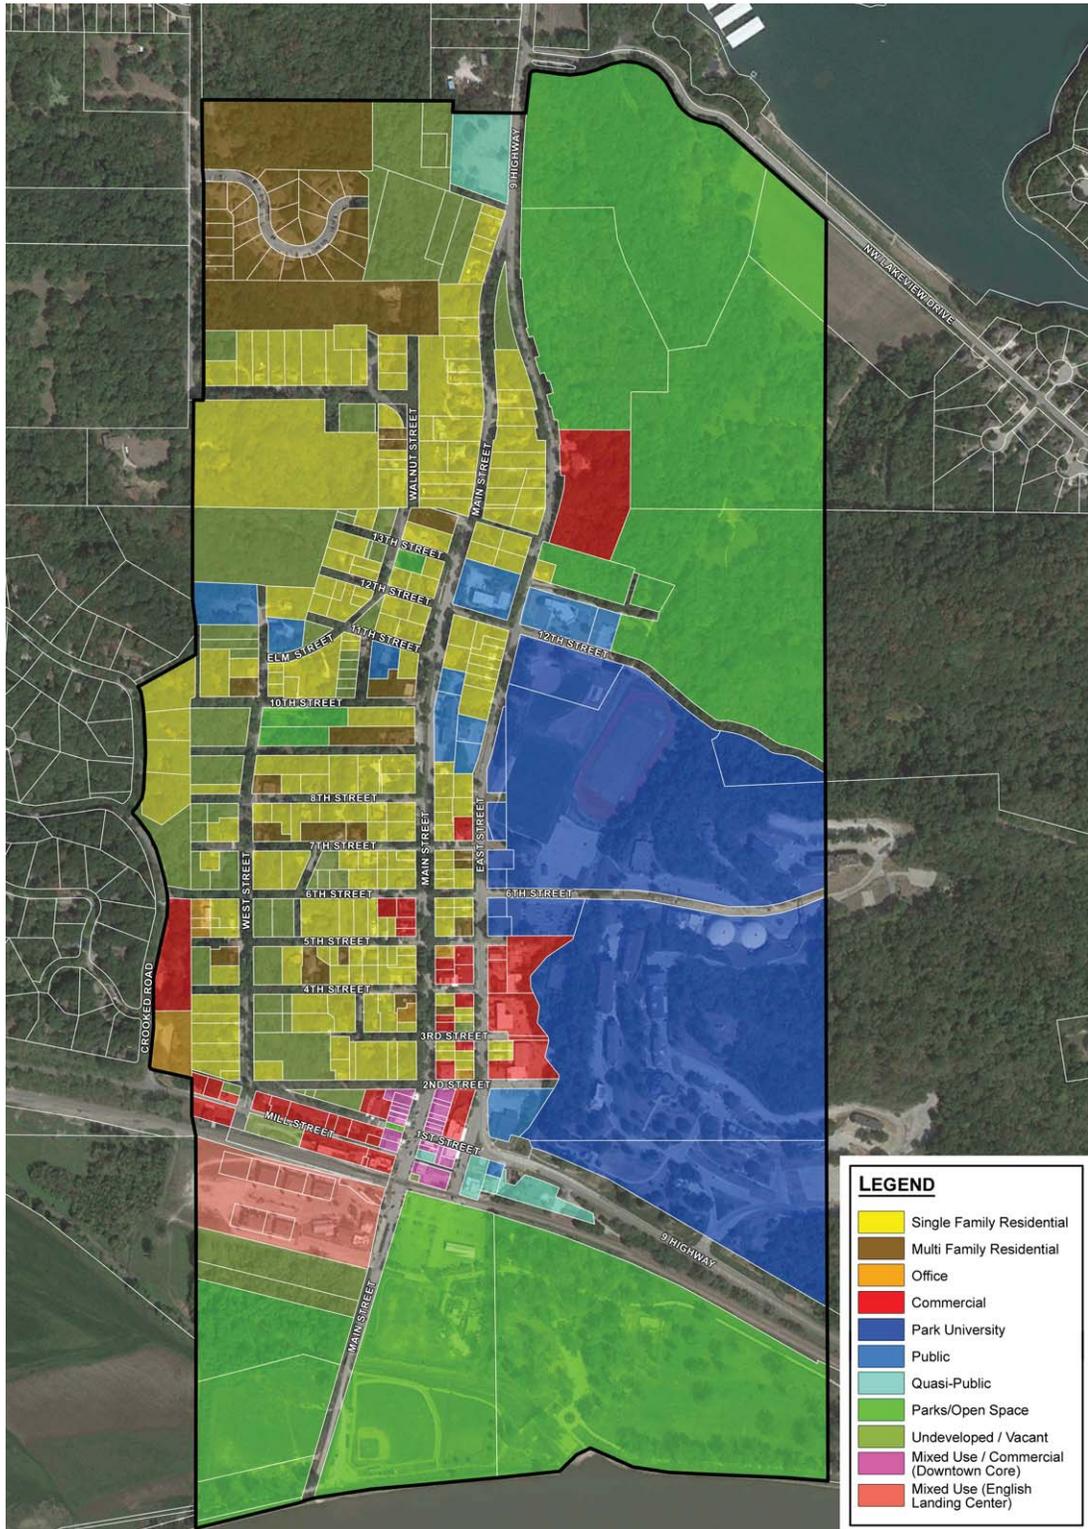
Fig. B.3 – Existing Land Use Map

For a closer examination, the Existing Land Use Map shown in Figure B.3 identifies the land uses for each parcel within downtown Parkville.

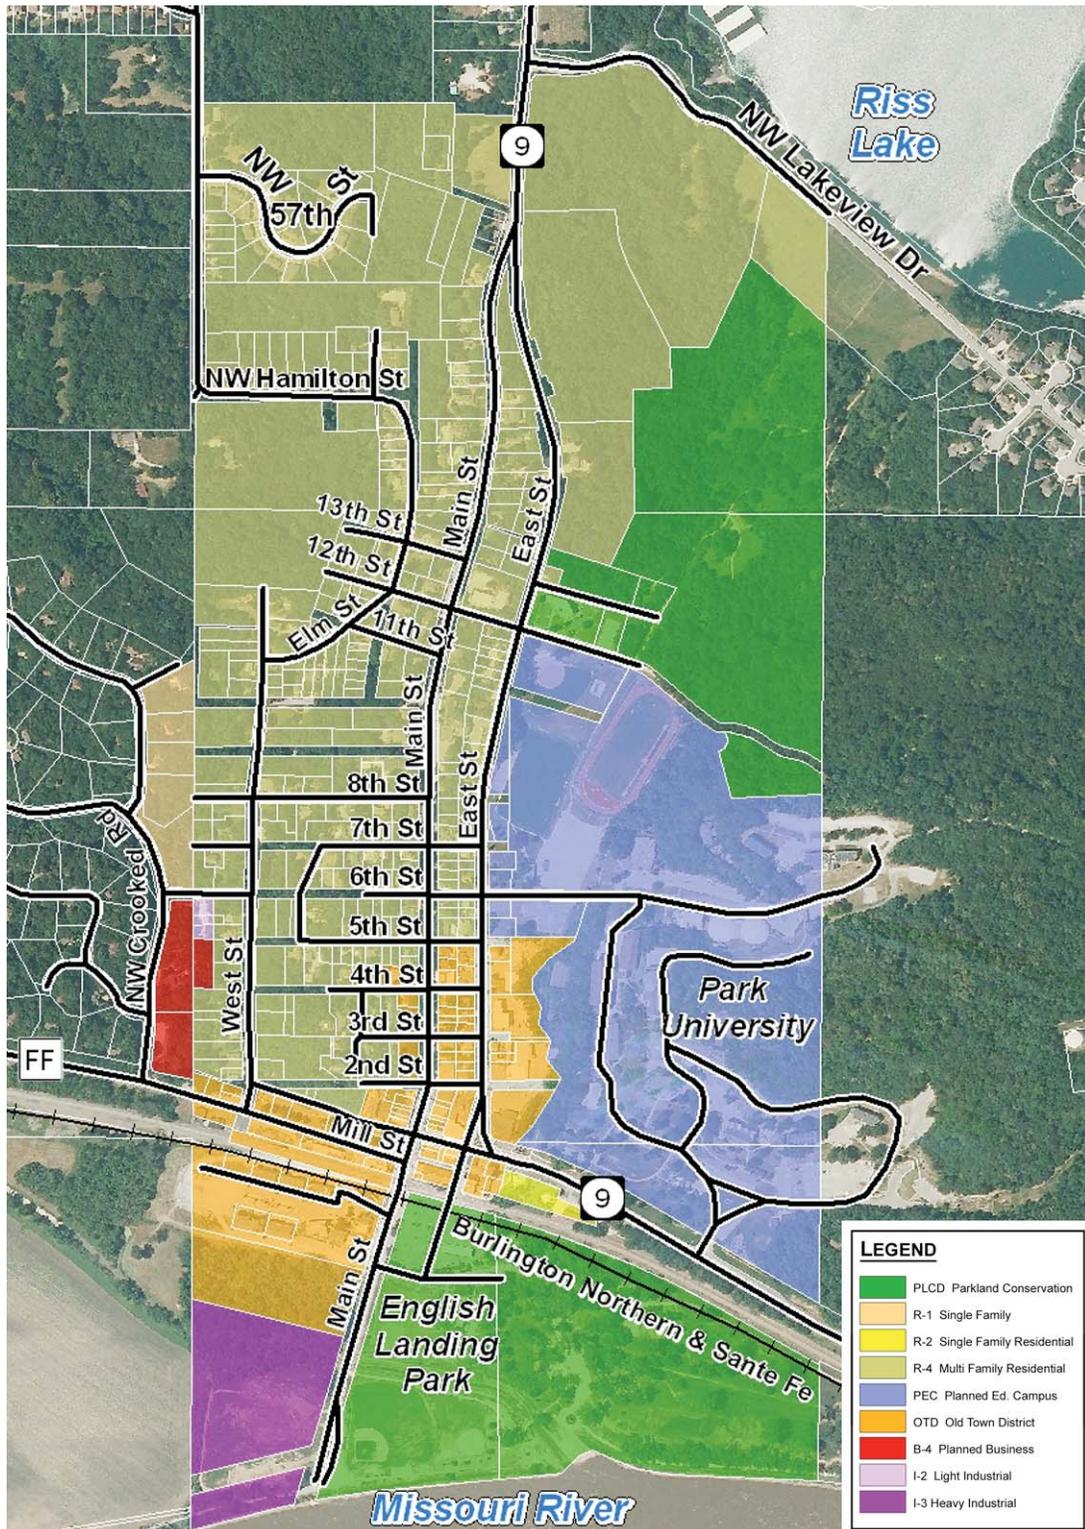
Fig. B.4 – Existing Zoning Map

The City of Parkville adopted the current zoning map, depicted in Figure B.4, in December, 2008. The map projects development of the City in a manner that protects the health, safety, prosperity, and general welfare of its residents. Zoning within the downtown area includes the following districts:

- **PLCD** Parkland and Conservation District
- **R-1** Single Family District
- **R-2** Single Family Residential District
- **R-4** Multiple Family Residential District
- **PEC** Planned Educational Campus
- **OTD** Old Town District
- **B-4** Planned Business District
- **I-2** Light Industrial District
- **I-3** Heavy Industrial District

The downtown residential neighborhood is zoned “R-4” throughout. This district allows for single family, two family, multifamily, apartment buildings, lodging and bed and breakfast establishments, and religious or non-profit uses.

The commercial core of downtown is zoned “OTD.” The Old Town District permits a mix of uses typical of downtown development. Residential dwellings units are allowed, “when located within a structure that contains retail space on the street level” (Source: City of Parkville Zoning Code). The OTD has design guidelines and detailed sign requirements that aim to maintain the look and character of downtown. Currently, while this designation is a part of the code, no properties have been rezoned OTD.

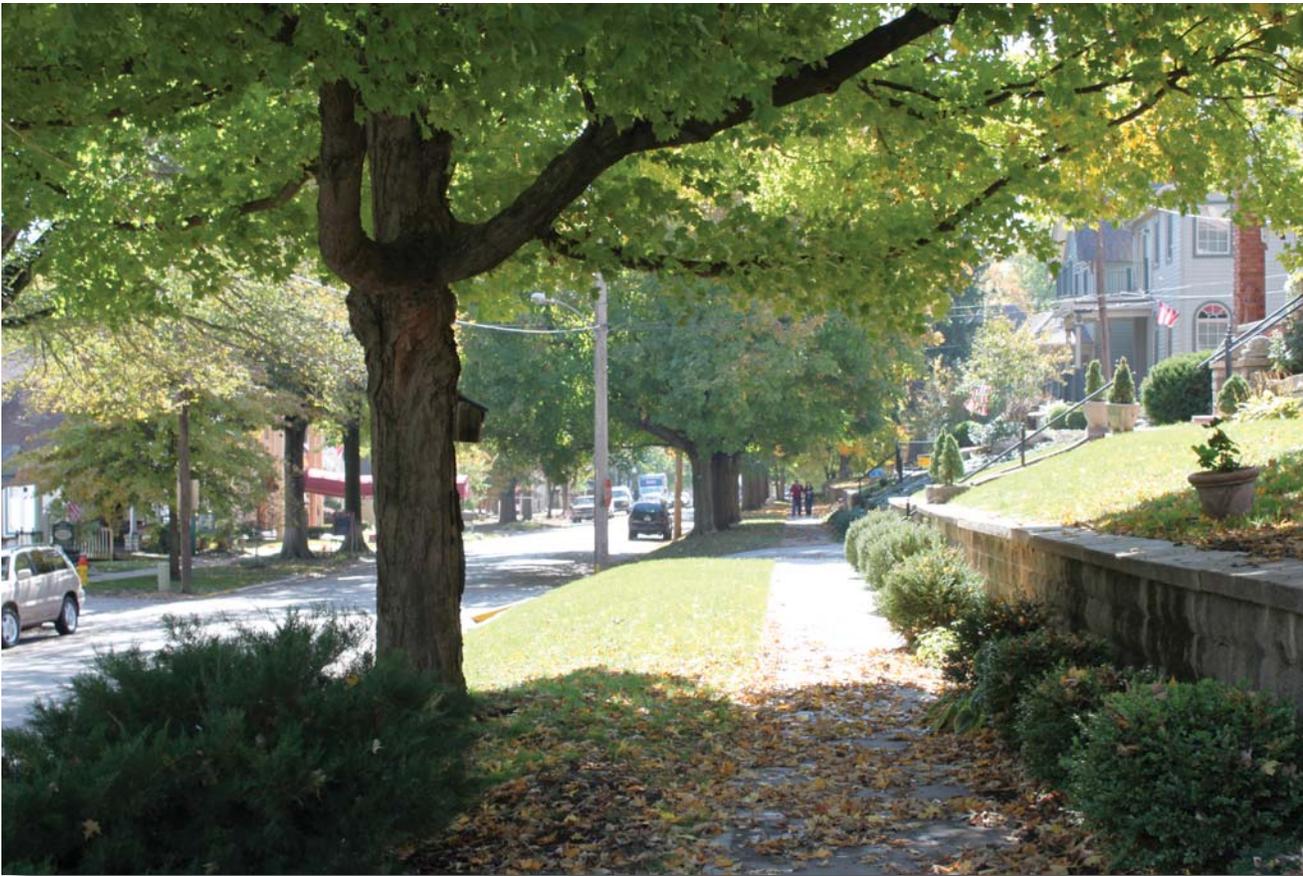
Fig. B.5 – View looking south along Main Street (SRJA, 2012)

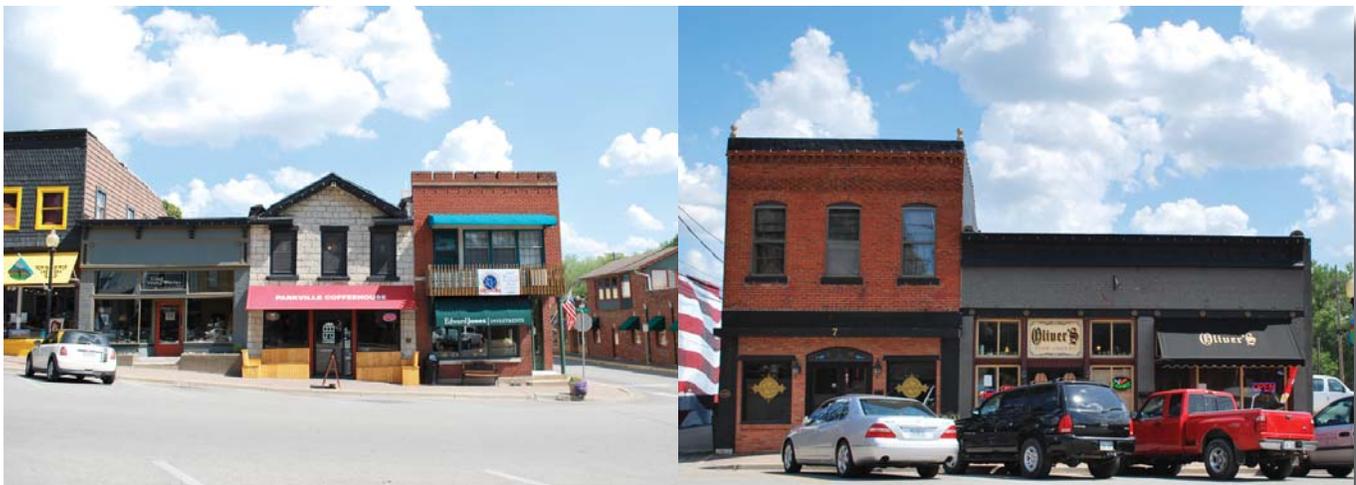
Fig. B.6 & B.7 – Views looking east along Main Street (SRJA, 2012)

One of the most identifiable areas of downtown is the two block stretch of Main Street from the railway to 2nd Street. The buildings are occupied by a mix of shops, services, and dining options. Buildings vary in quality, level of maintenance, and repair. There is a significant amount of original context still remaining in Parkville's historic downtown, though throughout the years, it has been concealed below layers of non-original and sometimes inappropriate materials.

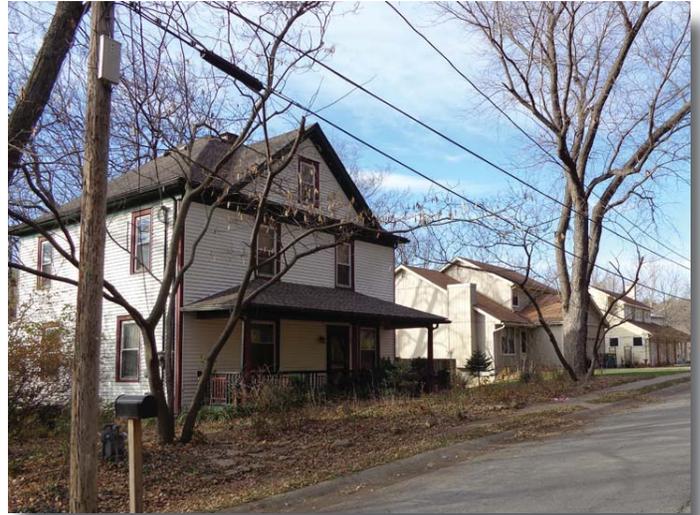
Fig. B.13 – The character of the built environment along West Street is quite different from Main Street.

West Street is residential in nature and has a completely different character than Main Street. Trees in front yards take the place of street trees. Streets are uncurbed. Sidewalks are sporadic. The general character of the homes varies greatly and includes many suburban style homes that are incongruous with the historic nature of the rest of the project area. There are numerous properties with distressed conditions, and vacant properties as well.

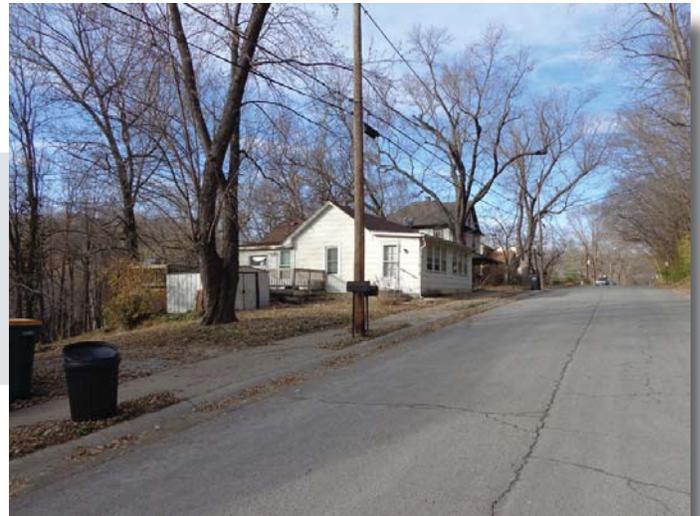
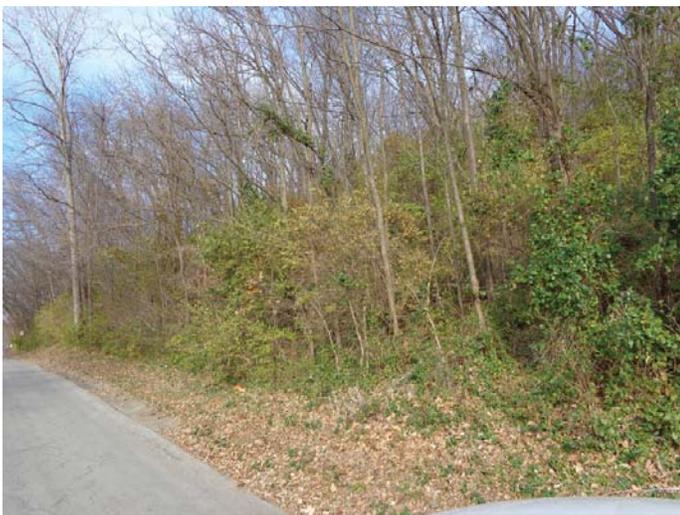
Fig. B.14 – The hilly topography and dense woodlands that border the east side of West Street would make further development in this area difficult.

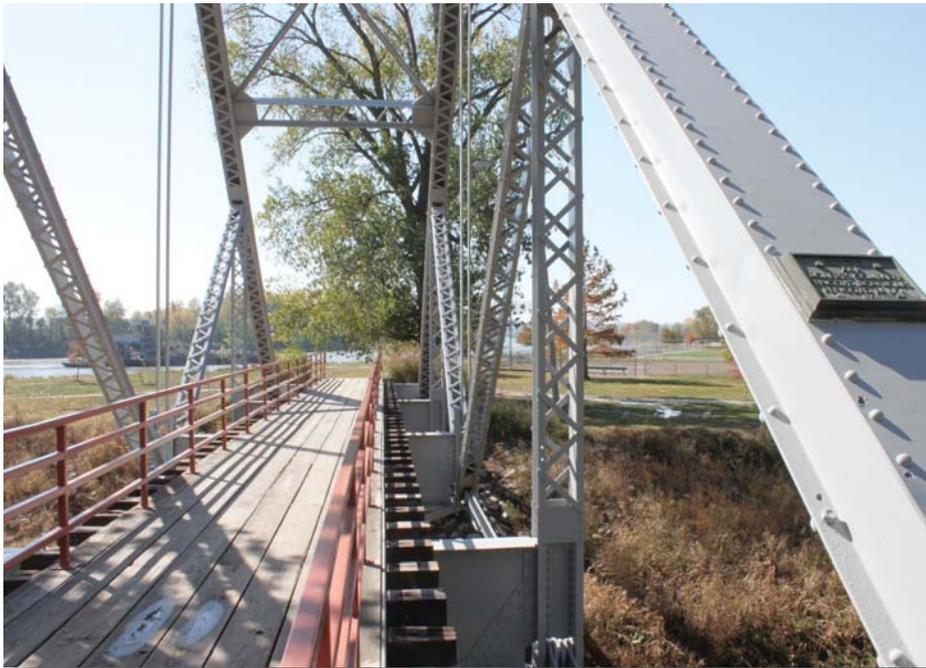
Fig. B.15 – Historic ‘Wadell “A” Truss Bridge (SRJA, 2012)

Parkville has a long and rich history in the region and actually has a number of individual structures that are currently listed on the National Register of Historic Places. However, the only structure within the downtown area that is currently listed on the National Register is the ‘Waddell “A” Truss Bridge’ located in English Landing Park.

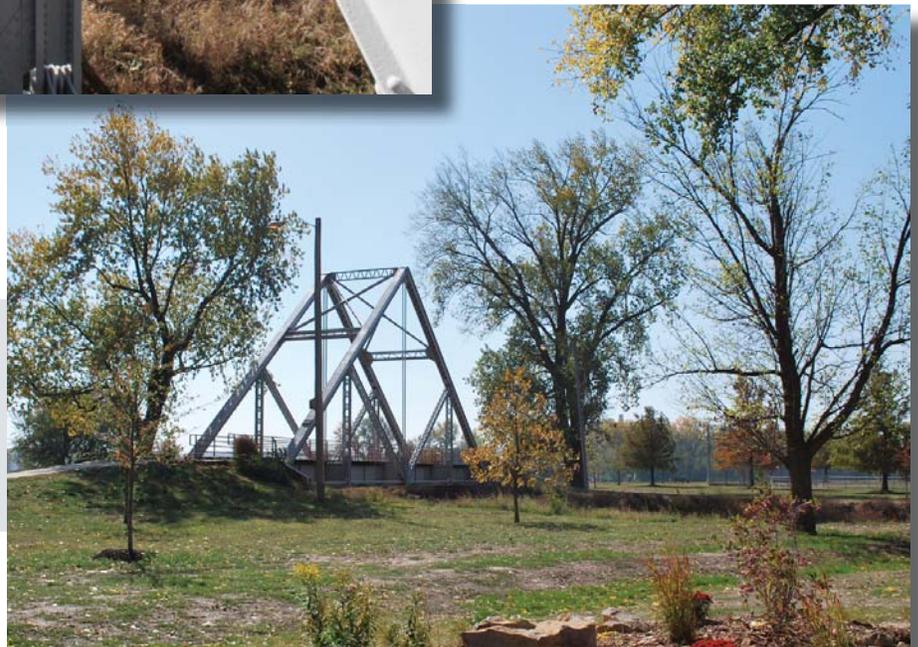
Fig. B.16 – Historic ‘Wadell “A” Truss Bridge (SRJA, 2012)

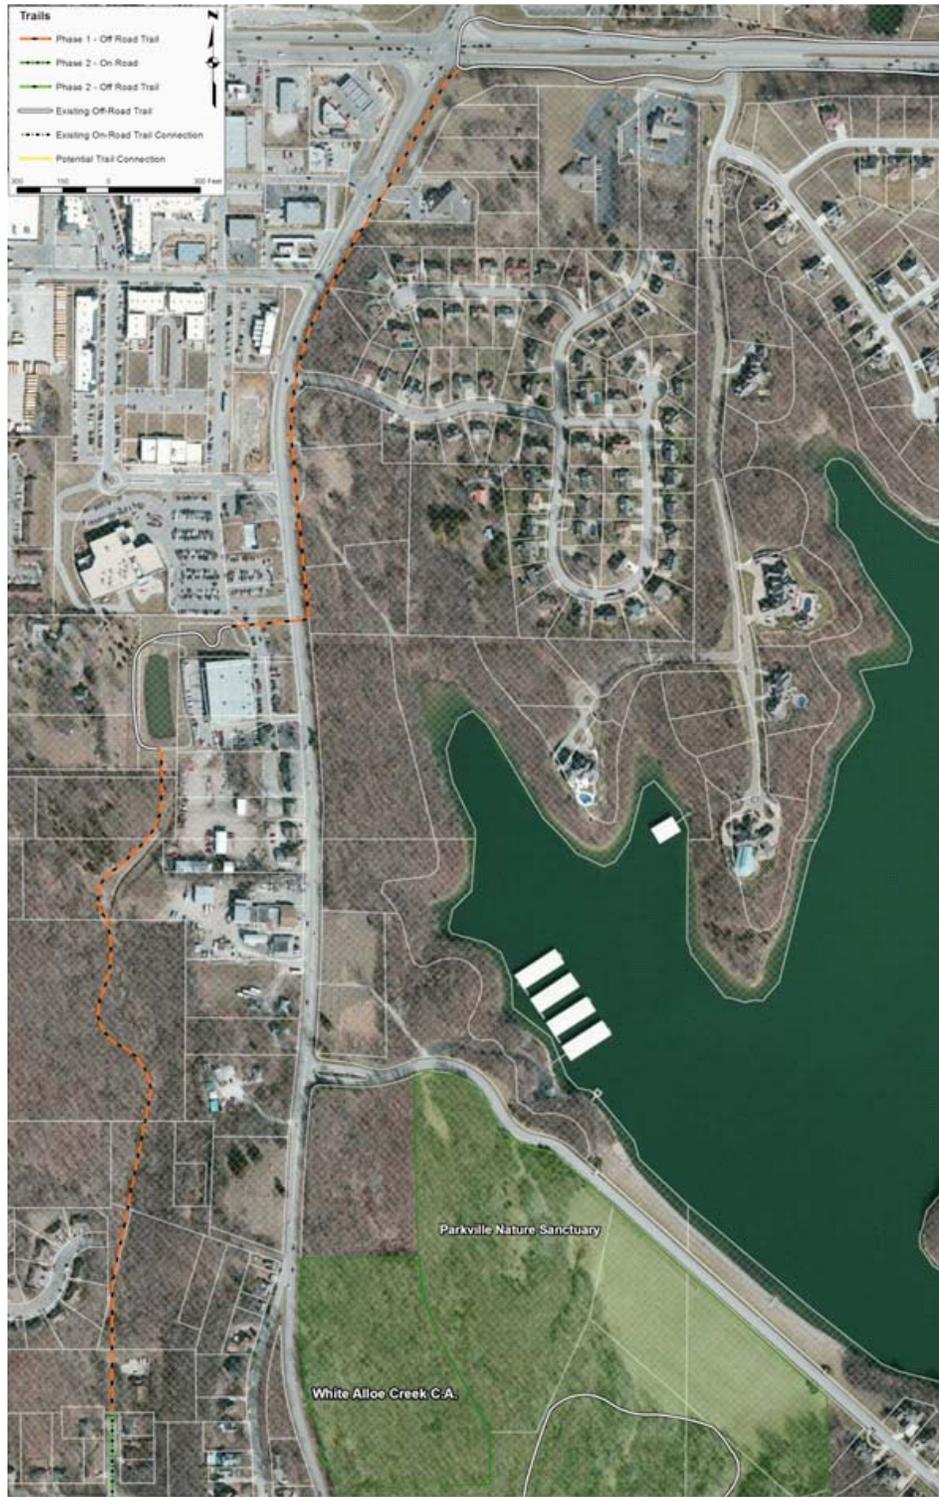
Fig. B.19 – Phase 1 Trail Exhibit (TranSystems 2012)

Phase I of the trail would start on the east side of MO Rte 9 and travel south for nearly 2,000 feet until crossing MO Rte 9 at the Platte County Community Center. Here the trail becomes an off-road trail connecting to a path around an existing detention pond west of the community center before heading south again for another 2,000 feet passing near the east edge of 51st Street and then connecting into Honor Lane.

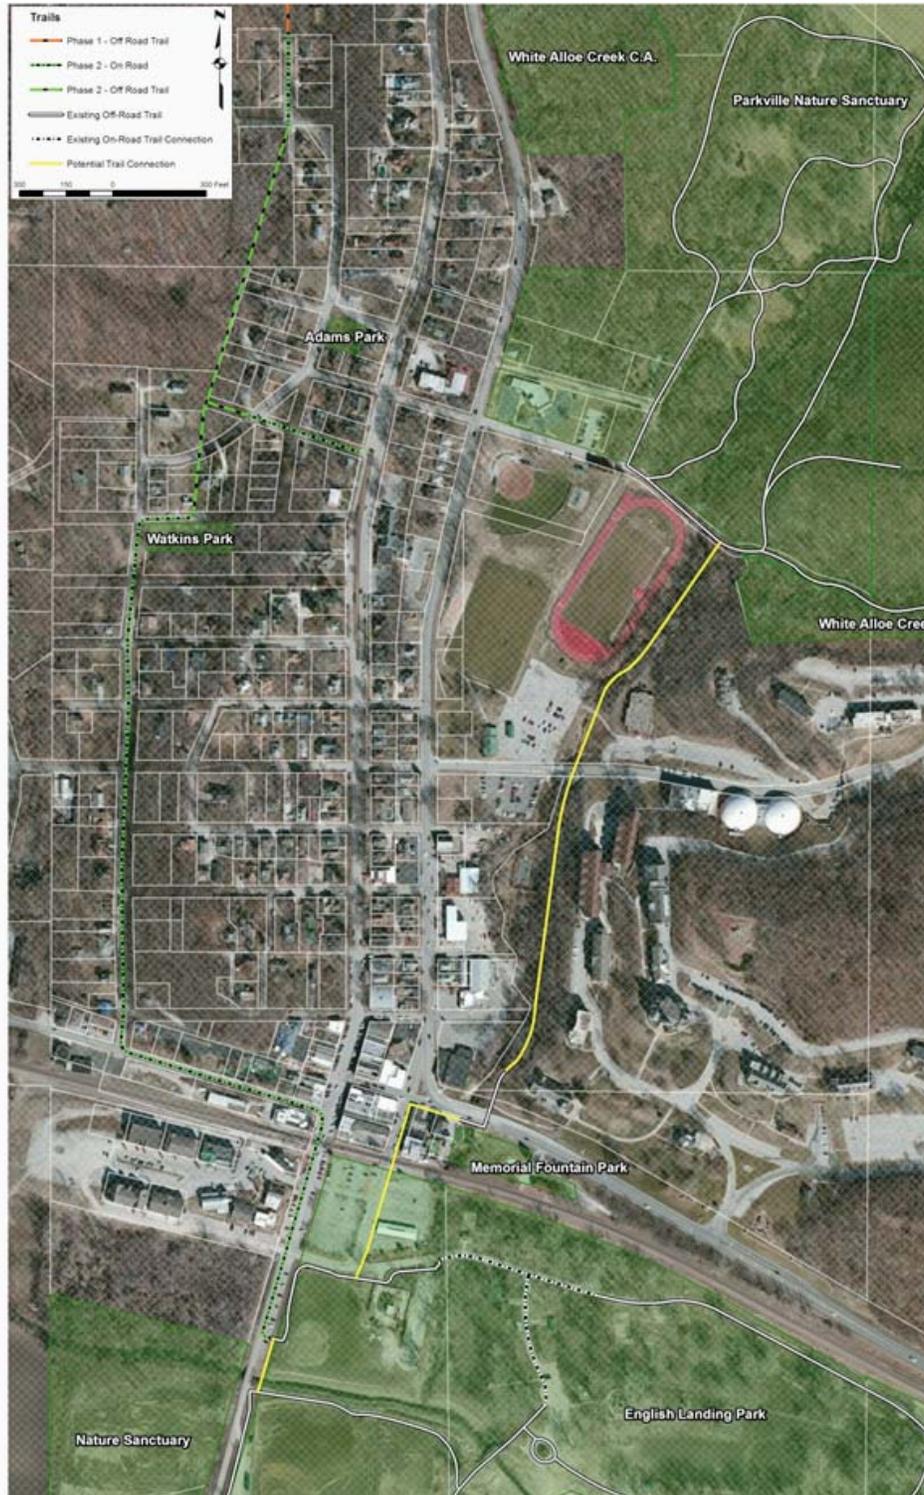
Fig. B.20 – Phase 2 Trail Exhibit (TranSystems 2012)

The Phase II trail is shown schematically along Honor Lane crossing Hamilton Street and heading south following along the western property lines of homes along Elm Street for approximately 1,500 feet. A connection is shown along 12th Street towards Main Street. The trail then crosses Elm Street and 10th Street entering

Watkins Park. The trail then exits Watkins Park and heads south along West Street for approximately 1,500 feet before turning easterly along Mill Street for 700 feet to Main Street.

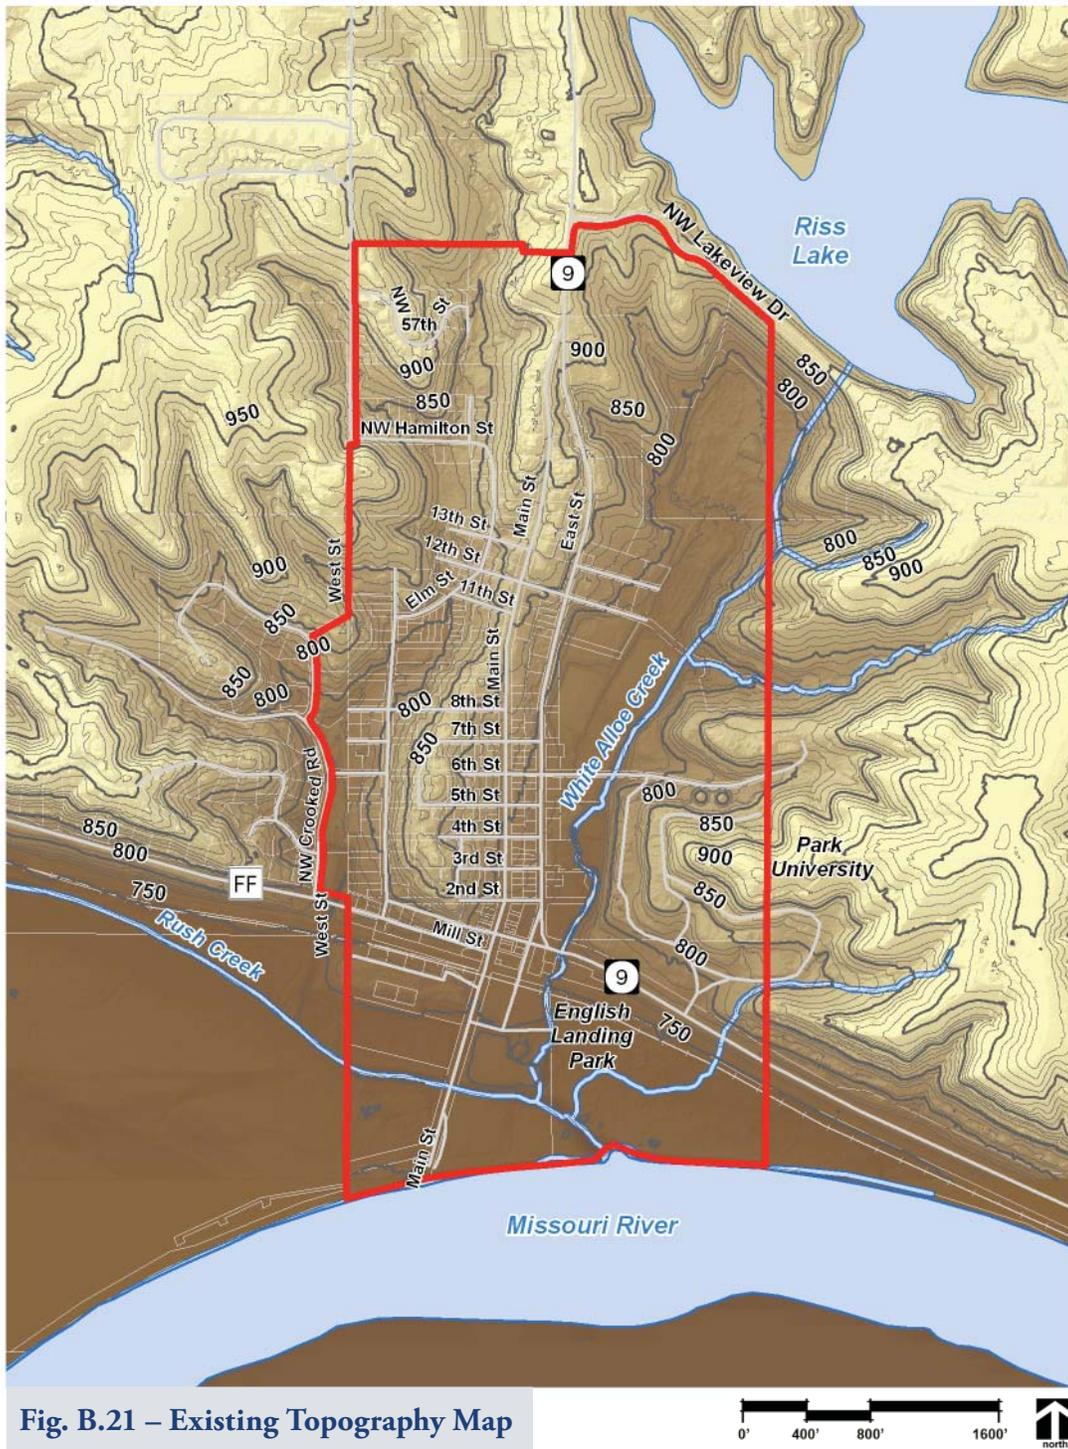
Fig. B.21 – Existing Topography Map

One of the defining features of Downtown Parkville is the dramatic grade change that occurs throughout the study area. In general, the entire area slopes toward the Missouri River along the south edge. Rush Creek feeds into the river from the west, and White Alloe Creek feeds into Rush Creek from the north. Park University sits on a ridge east of White Alloe Creek that isolates it from much of the downtown area to the west. There is also a major ridge that runs through the center of the downtown, west of Main Street. The ridge has a significant impact on the residential neighborhood between 2nd Street and 12th Street. The vacant property and undeveloped streets that exist within the west half of the neighborhood are likely a result of challenges created by the steep slopes and dense vegetation of the area.

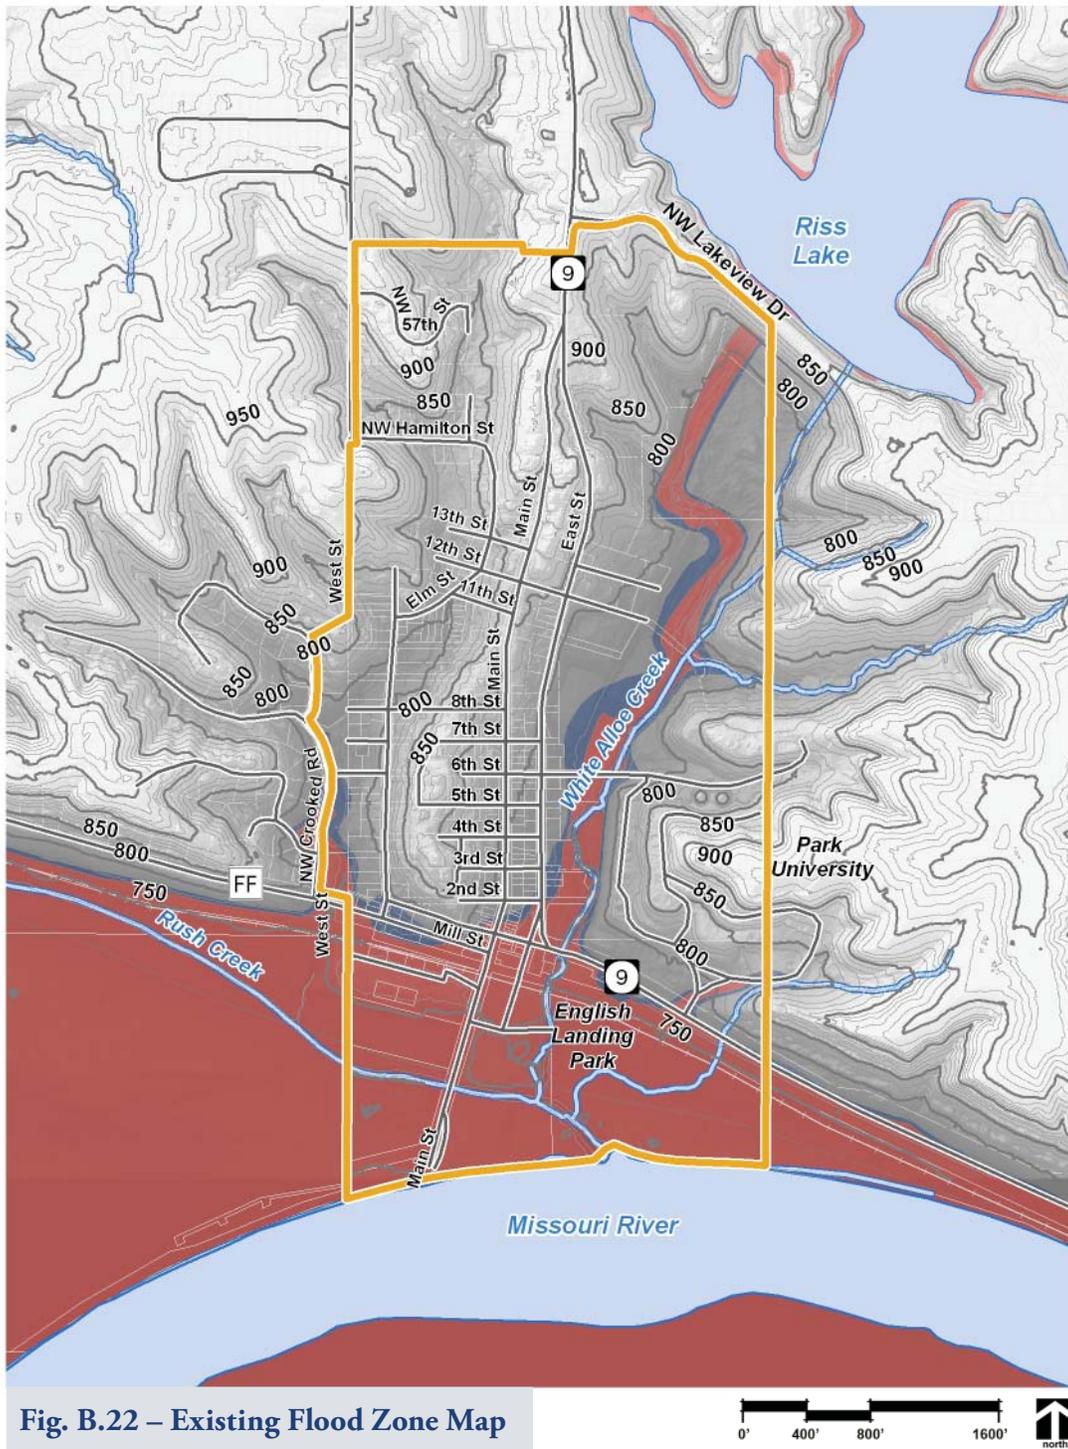
Fig. B.22 – Existing Flood Zone Map

The City and the U.S. Army Corps of Engineers monitor Missouri River levels every year for the potential for flooding. Historically, flooding has been addressed by building dams using portable units and sandbags. Damages to English Landing Park are caused by flood waters that are unable to drain.

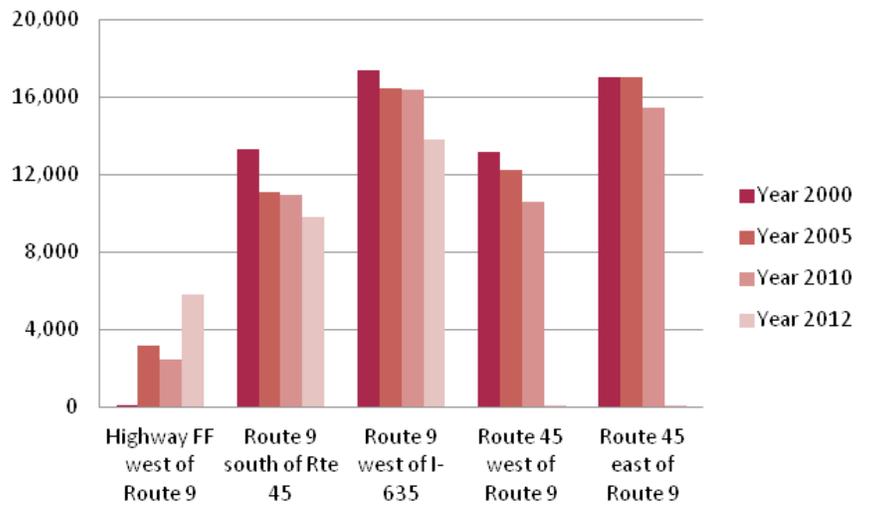
Fig. B.23 – Historic Traffic Volumes

Historic growth along the state highways through the Downtown and a few other highways around Parkville show a consistent decline along many of the corridors including MO Routes 9 and 45 as well as Highway FF. Over a 10-year period from 2000 to 2010, traffic volumes as reported from MoDOT traffic volume maps, all showed a decline as illustrated in Figure B.23. While many of the count locations are not directly in the Downtown area, they should reflect an overall trend in traffic volumes. In many locations, changes over a five year period (either 2000 to 2005, or 2005 to 2010) were nominal. Traffic volume data was not available for the year 2000 along Highway FF.

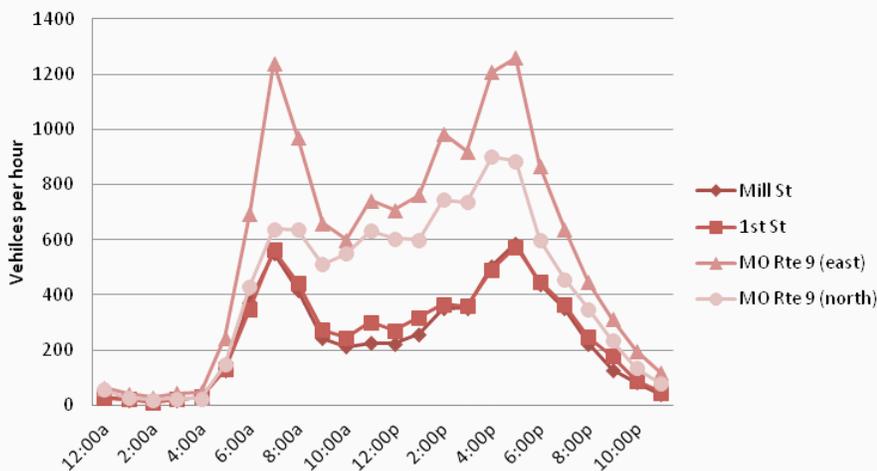
Fig. B.24 – Hourly Traffic Volumes

Traffic distributions follow expected commuter patterns of predominantly eastbound in the AM and westbound in the PM along the MO Rte FF/9 corridor. A similar patterns occurs on Route 9 in the north-south orientation; southbound in the AM and northbound in the PM. The FF/9 corridor also follows a near equal total peak for both the AM and PM traffic reaching just shy of 1,200 vehicles per hour (vph) for MO Rte 9 (east) and nearly 600 vph for Highway FF. On the other hand, MO Rte 9 to the north has a higher PM peak (at 900 vph) that the AM peak (over 600 vph) although these volumes last for more than the one hour peaking period.

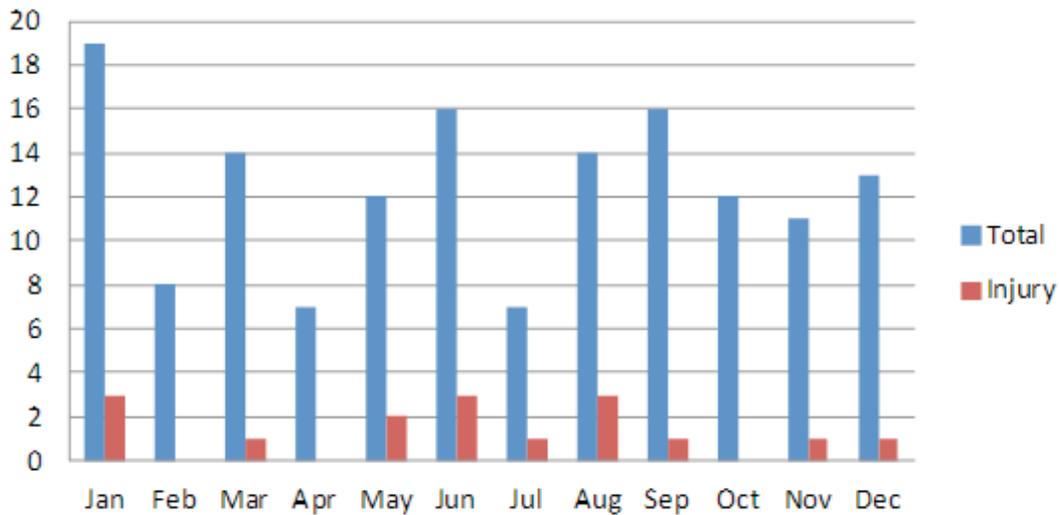
Fig. B.27 – 5-Year Accidents (2007-2011)

a five-year period from 2007 through 2011. During that time period, 149 total accidents were recorded with 15 injury accidents and one fatal accident. The fatal accident involved a pedestrian along MO Rte 9 at 4th Street. The total number of accidents jumped from 27 in 2008 to 37 in 2010. Figure B.27 shows the total accidents and injury accidents by month over the five-year period. January had the most accidents (at 18) followed by June and September (at 16 each). Figure B.28 shows the breakdown of accidents by classification. The top three types of accidents were rear-end, out of control, and right angle. These three classifications encompass 45% of the total accidents and include a majority (56%) of the injury accidents. The overall percentage of injury accidents is 10% which is relatively low. A dot-plot over the five year period of the crash locations is shown in Figure B.29.

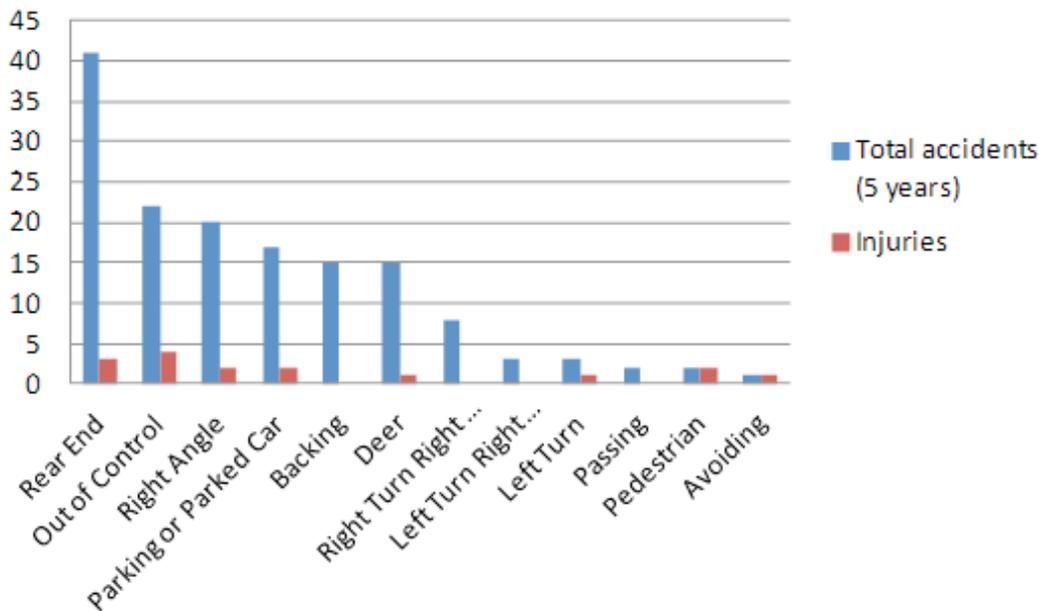
Fig. B.28 – 5-Year Accidents (2007-2011) by Type

- The majority (82%) of all accidents are intersection related.
- The majority (75%) of all accidents occur under clear weather.
- The majority (79%) of all accidents occur under dry road surface conditions.
- The majority (73%) of all accidents occur under daylight conditions.
- Half (50%) of injury accidents occur during daylight conditions.

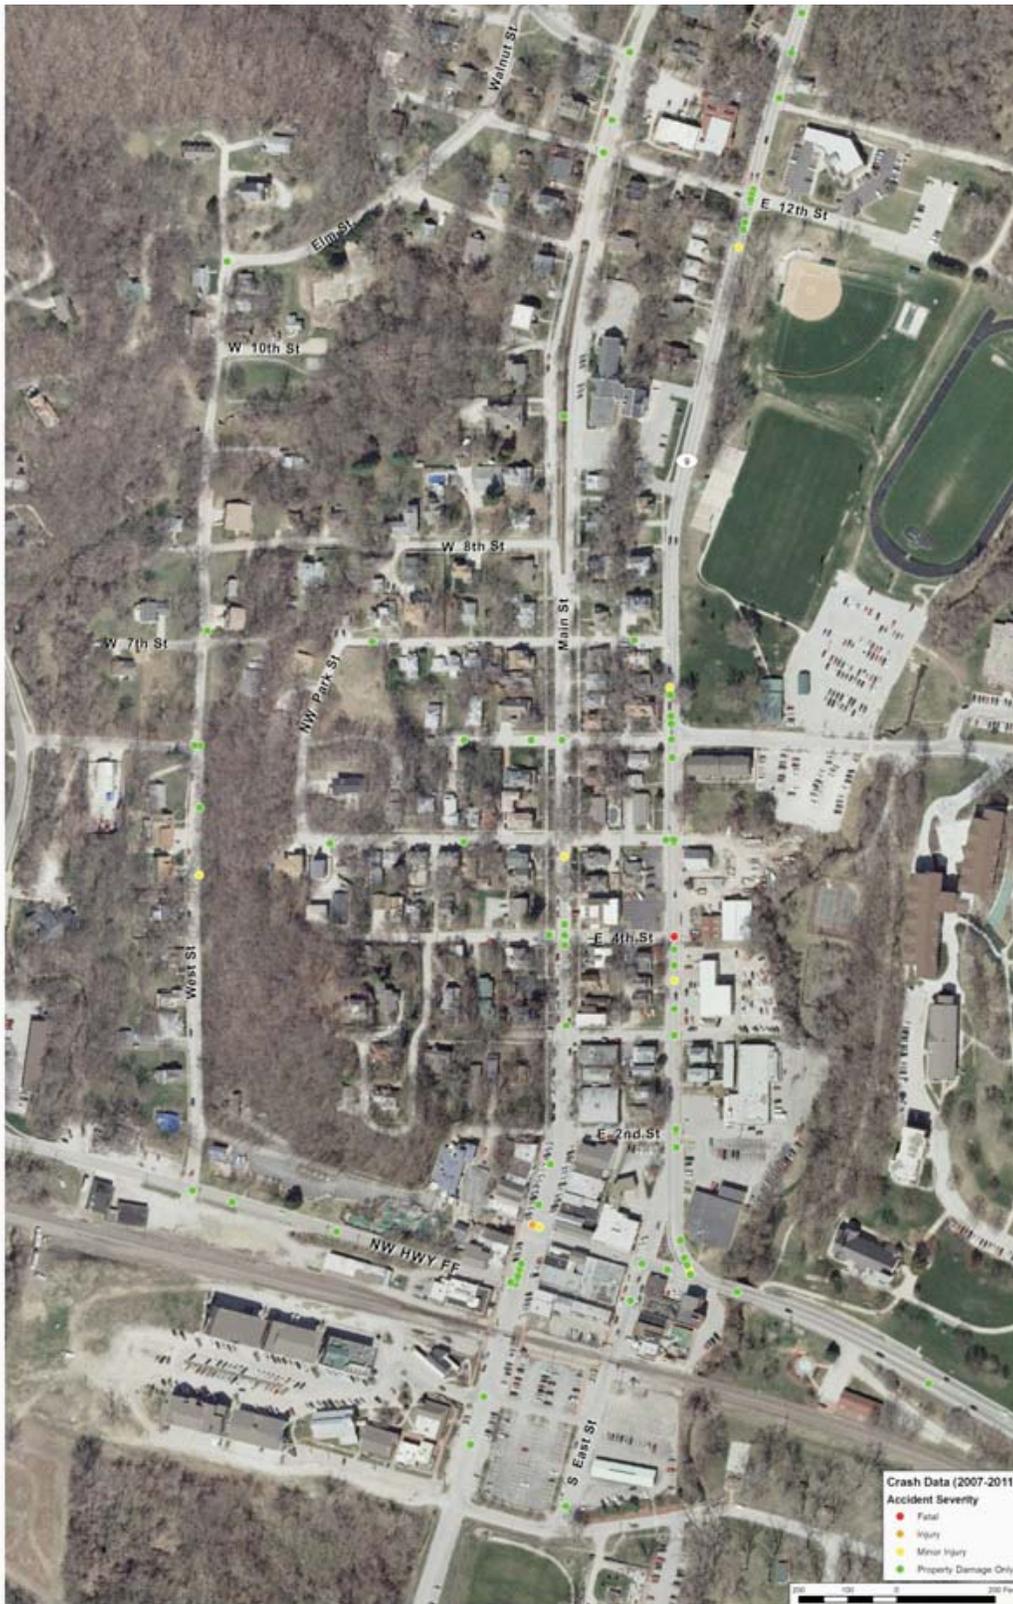
Fig. B.29 – 5-Year Accident Locations

While several accidents occurred in the study area and some clustering of accidents can be noted, a positive aspect is that in general the injury percentage is low. Unfortunately a fatal accident occurred with a pedestrian across MO Rte 9. A comparison to statewide average accident rates is not applicable as the segment lengths within the study area are shorter than required and would result in artificially high crash rates.

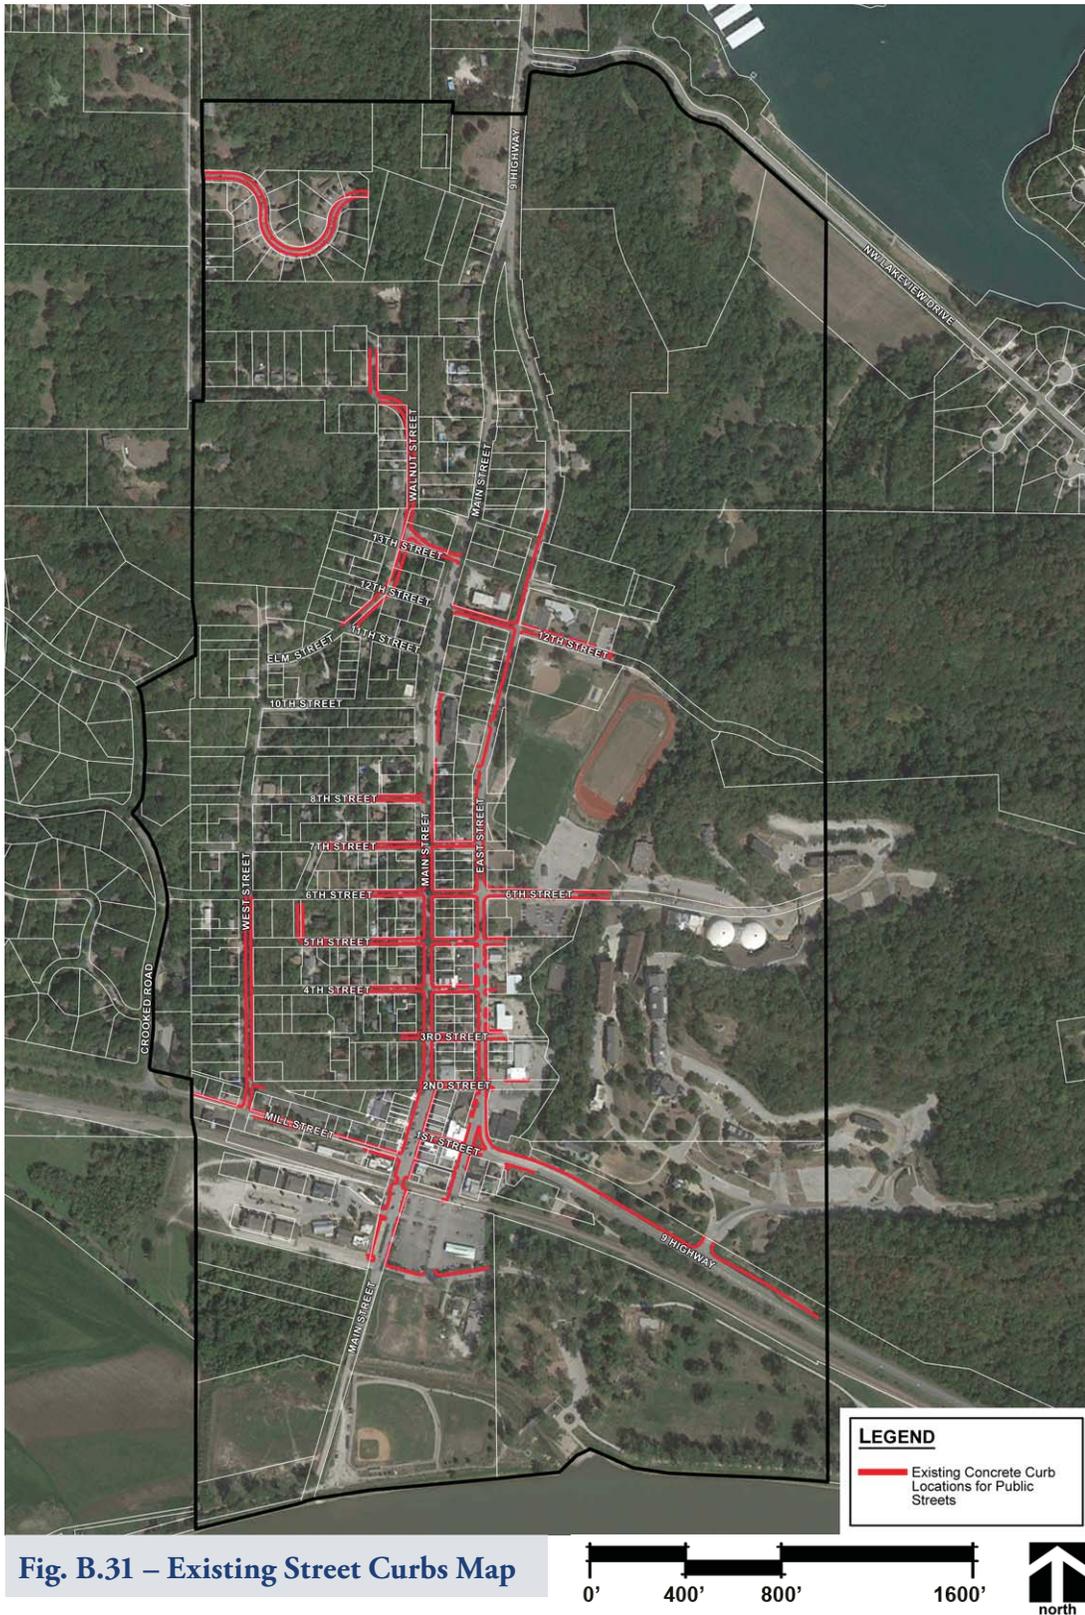
Fig. B.31 – Existing Street Curbs Map

The condition of the concrete curbs varies throughout the area. The curbs in the downtown core are in fairly good condition. However, the condition and even existence of the curbs in the residential neighborhood is much more inconsistent. The west half of the residential neighborhood (west of Main Street), extending up to 11th Street, is essentially devoid of consistent curbing. Main Street is also lacking curbs from 8th Street to the northern downtown area boundary. Those curbs that do exist within the neighborhood vary in quality. Many of the older curbs have begun to show signs of the “disappearing curb” effect. Multiple overlays of the asphalt streets over the years have essentially raised the elevations of the streets to the extent that only two to three inches of the curb are visible in some locations. This can sometimes cause drainage concerns along the fronts of residents’ properties.
