APPENDIX B: Existing Conditions

Existing Conditions

B.1 Introduction

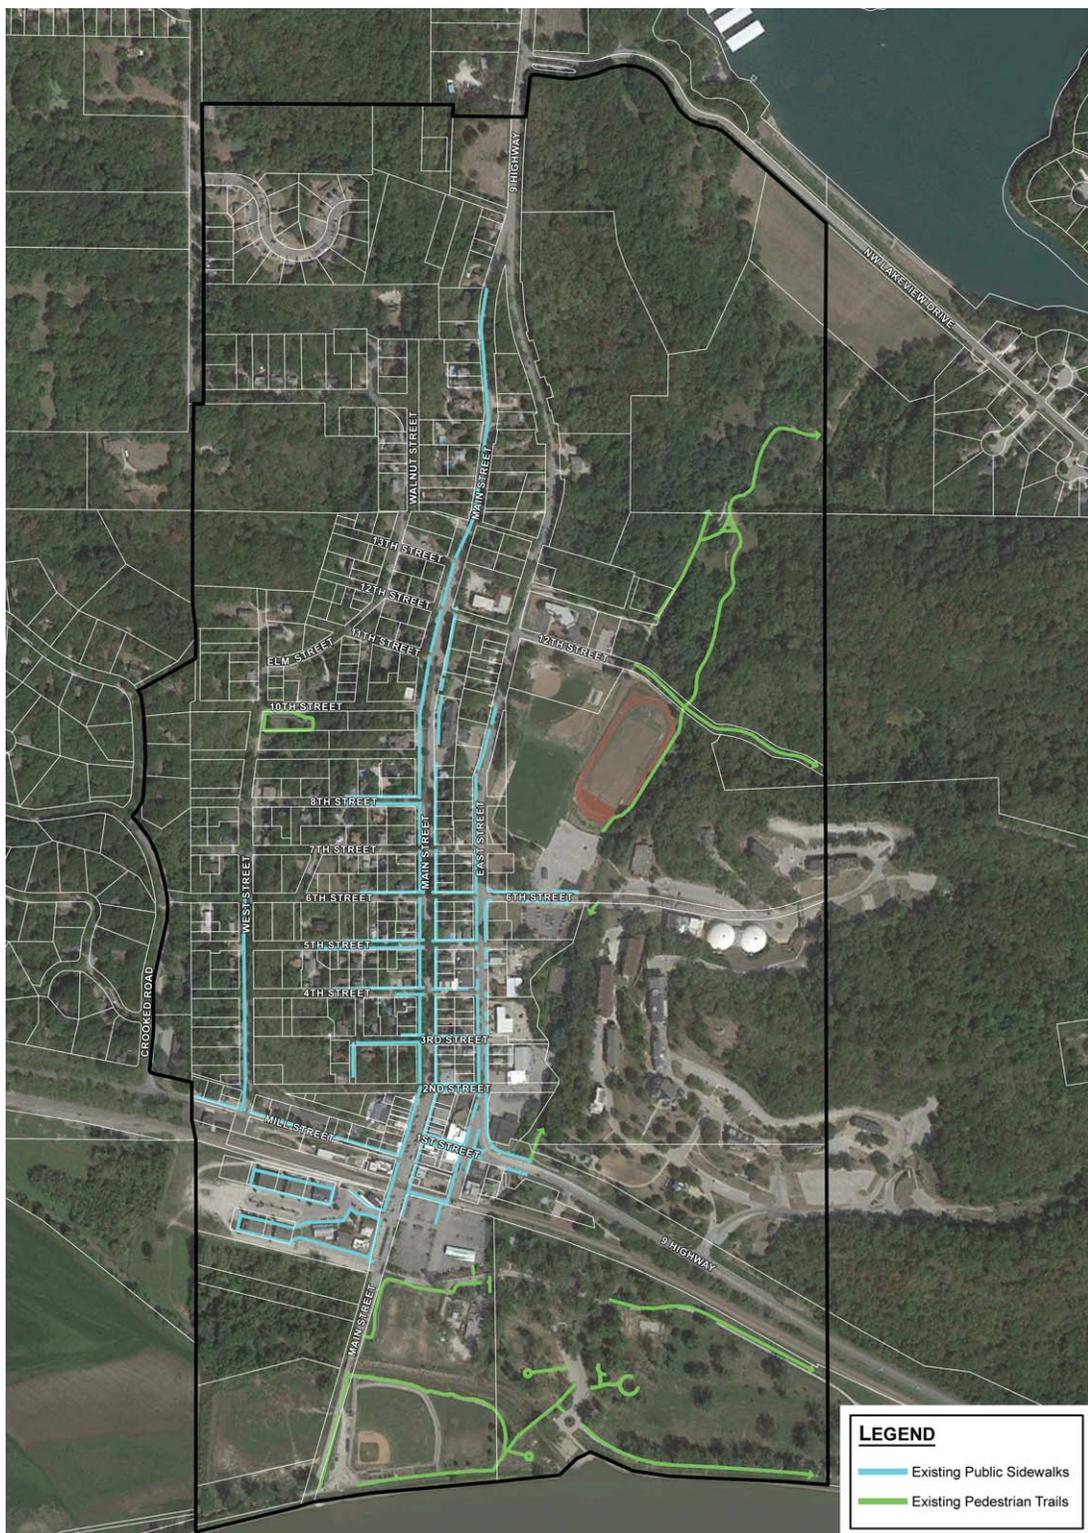
Fig. B.32 – Existing Sidewalks and Trails Map

Pedestrians - Observations of pedestrians were made on a Friday and Saturday at approximately noon. The locations included 1st and MO Rte 9, Main Street at the railroad tracks, and the “square” at Mill, Main and 1st Streets. Saturday was busier except at the crossing of MO Rte 9. On Friday, six of the 23 observations crossing MO Rte 9 were observed to enter the Patriot Bank.

Saturday observations of pedestrians crossing the railroad tracks at both Main Street and East Street indicate several groups of people. Statistically there were 1.9 people per crossing observation. The Main Street crossing was busier and accounted for 87% of all crossings observed. The heavily traveled direction was northbound at 53% of all crossings. During the one hour count period, three trains went through the crossing and blocked the crossing for approximately four minutes each time. The off-street parking lot

was observed to be more than half full on Saturday. A similar crossing pattern utilizing Main Street was noted on Friday. On Friday, the off-street parking lot was only marginally utilized.

The junction of Mill/Main/1st Street is a busy intersection for pedestrians. Nearly double the number of pedestrians were observed on Saturday as compared to Friday. Again many observations had groups of people, up to four in a crossing. Crossings were nearly equal in a cardinal direction; 29% cross to the west, 25% cross to the east, 25% cross to the south and 23% cross to the north. On several occasions crossings were made in multiple directions by the groups being observed. On-street parking was fully utilized (greater than 80%) on both Friday and Saturday. Observations indicated little parking turnover within the hour.
